# Inhibition of demand pacemaker by leakage current from electrocardiographic recorder

J. Meibom and J. Damgaard Andersen

From the Department of Medicine B, University Hospital (Rigshospitalet), Copenhagen, Denmark

*A 76-year-old man had his implanted demand pacemaker inhibited by an electrical leakage current caused by defective grounding in an electrocardiographic recorder power cable. Various measures can be undertaken in order to minimize this hazard, and these are discussed.*

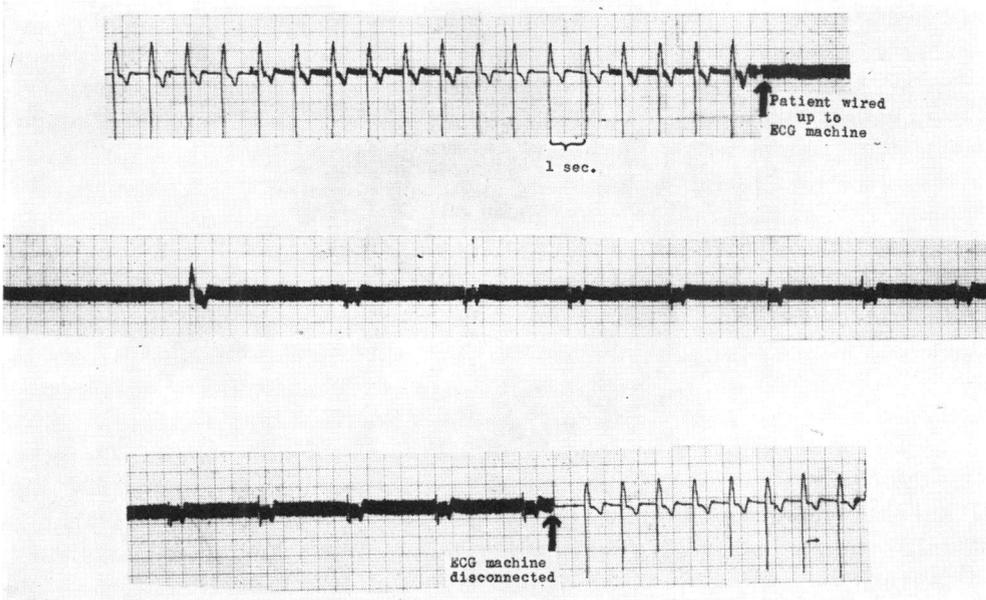
Two days after implanting the permanent pacemaker the patient fainted when he was connected to an electrocardiographic recorder for the purpose of recording a 12-lead diagnostic electrocardiogram. He was immediately disconnected and recovered in a few minutes. Since the period of asystole (as observed on a copy of the continuously recording tape, Fig. 1) seemed to be associated with the wiring up of the patient to the recorder, a careful examination of the electrical set-up and of the sensitivity of the pacemaker to external electrical influences was carried out. The patient has been followed for a year after discharge and he has not reported similar episodes during this period.

FIG. 1 Inhibition of demand pacemaker by 50 Hertz alternating current interference from electrocardiographic recorder. Relayed from continuously monitoring tape-recorder.

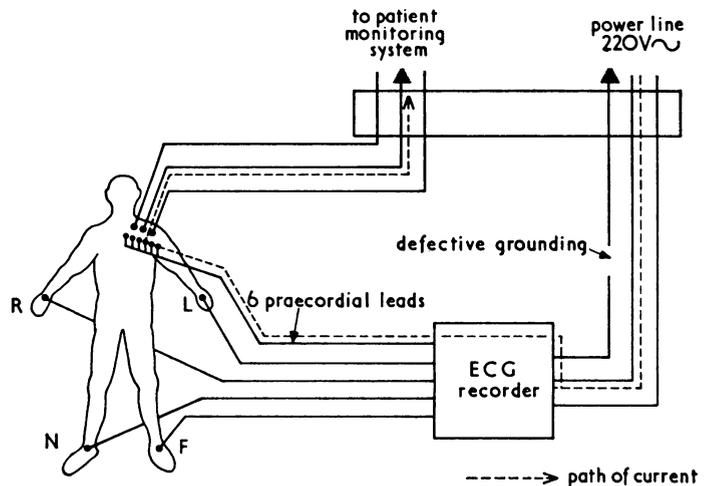
The wiring up of the patient to the electrocardiographic recorder (with power turned on) established the following current path: from the power supply outlet via the recorder through the patient and back to the power supply system ground via the central monitoring system (Fig. 2). Under normal conditions this path will carry a current less than 10 microamperes (peak-to-peak), but in this case the current was about 130 microamperes (measured with an oscilloscope connected between the monitoring system and the recorder, with the 6 praecordial and R, N, F, and L leads connected together as a common terminal). This was sufficient to arrest the im-

planted pacemaker, the threshold of inhibition later being measured to about 80 microamperes (same measuring set-up as above).

The high current passing from the recorder to the patient monitoring system was due to insufficient grounding of the electrocardiographic recorder because the ground cable in the power plug was defective. This caused the leakage current of the power cable and the recorder to flow through the patient and the monitoring system, instead of returning via the ground cable. Normally the capacitance between the windings of the power transformer in the recorder is low because a grounded shield is interposed between the windings. When grounding failed, capacitance between primary and secondary windings increased, and capacitance between power wire and ground wire in the power cable was added to this, so that the recorder acted as a current source of several megohms internal impedance. In this way, current is 'forced' through the patient, even in the presence of relatively high electrode impedances.

FIG. 2 Path of inhibiting current.

As other authors have stated (Whalen and Starmer, 1967; Weinberg, 1967), several measures can be taken in order to minimize electrical hazards, and these measures apply equally well to the care of patients with an implanted demand pacemaker. In this case we have found it important to take the following measures. (1) A technician should check the electrical equipment and installation in the

intensive care unit regularly according to a fixed schedule (visual inspection of plugs, cables, cases, etc., measurement of resistances, test of function). (2) Physicians and nurses should be educated in medical electronics, emphasizing the practical aspects: how to avoid electrical hazards and simple ways to check equipment and installation. (3) Regular checks of pacemaker function in patients suspected of carrying a demand pacemaker with

a low threshold of inhibition should be carried out.
