## IMAGES IN CARDIOLOGY

## New insight into plaque healing after plaque rupture with subsequent thrombus formation detected by intravascular ultrasound

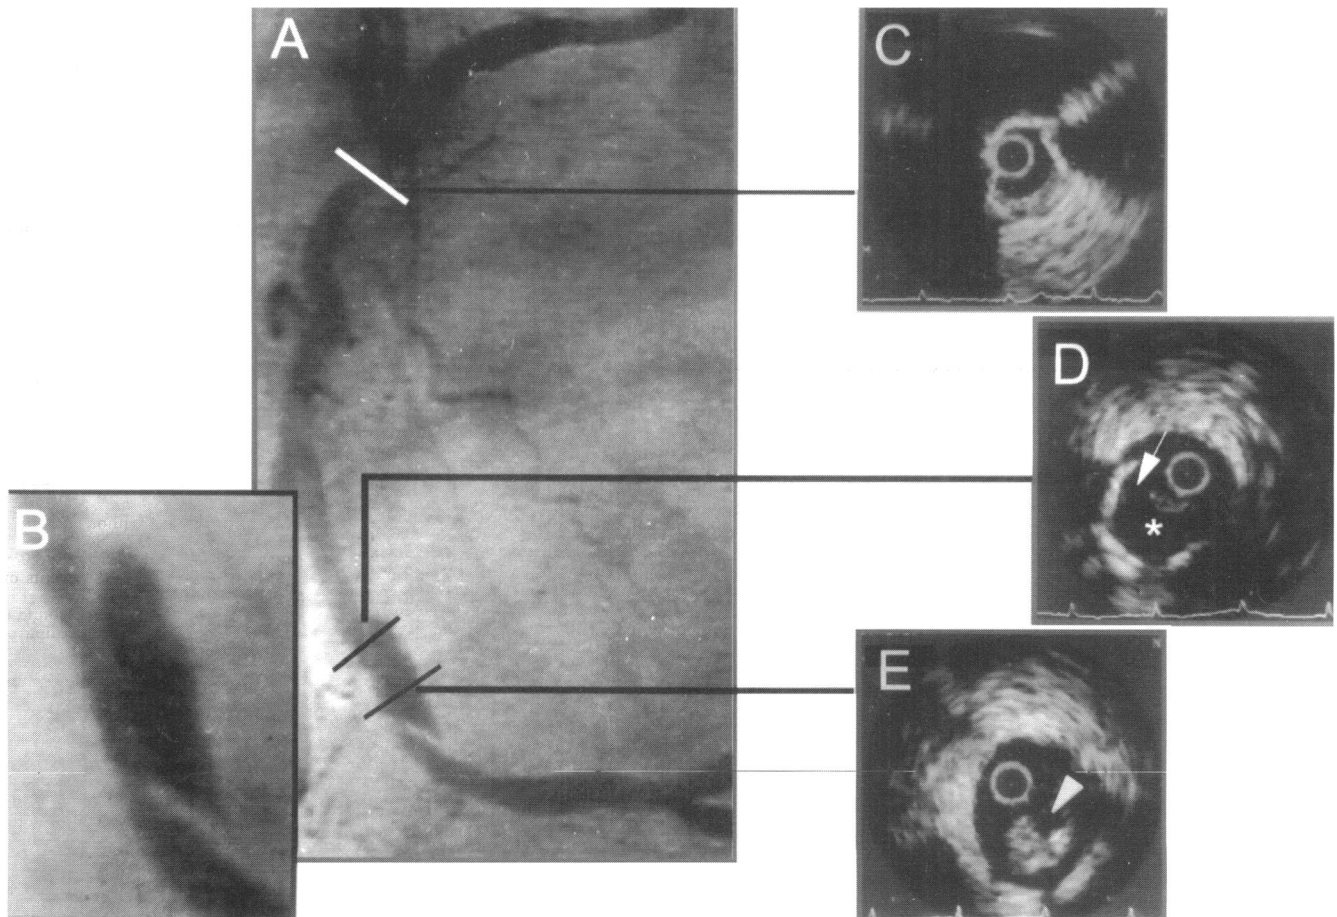
A 61 year old man with a three week history of unstable angina was admitted for cardiac catheterisation. Coronary angiography of the right coronary artery (RCA) showed a proximal concentric stenosis and distally a lesion that appeared to be a coronary aneurysm (A and B).

However, intravascular ultrasound (IVUS) identified the lesion as a plaque disruption (D). The arrow indicates the opening of the plaque rupture and the star indicates the false lumen of the washed out plaque. IVUS also showed an adherent thrombus within the cavity (E, arrowhead pointing to the thrombus). In the proximal stenosis IVUS showed a heavily calcified lesion with  $>270^\circ$  of acoustic shadowing (C).

Plaque disruption and subsequent washing out of the atheromatous content of the core induces thrombus formation and may lead to acute coronary syndromes. Recently, plaque healing was described as another possible result of plaque disruption. Our finding of a thrombus in the emptied cavity of a ruptured plaque may represent the key mechanism in the healing process.
