IMAGES IN CARDIOLOGY

Strut fracture of the Convexo-Concave Björk-Shiley mitral valve prosthesis

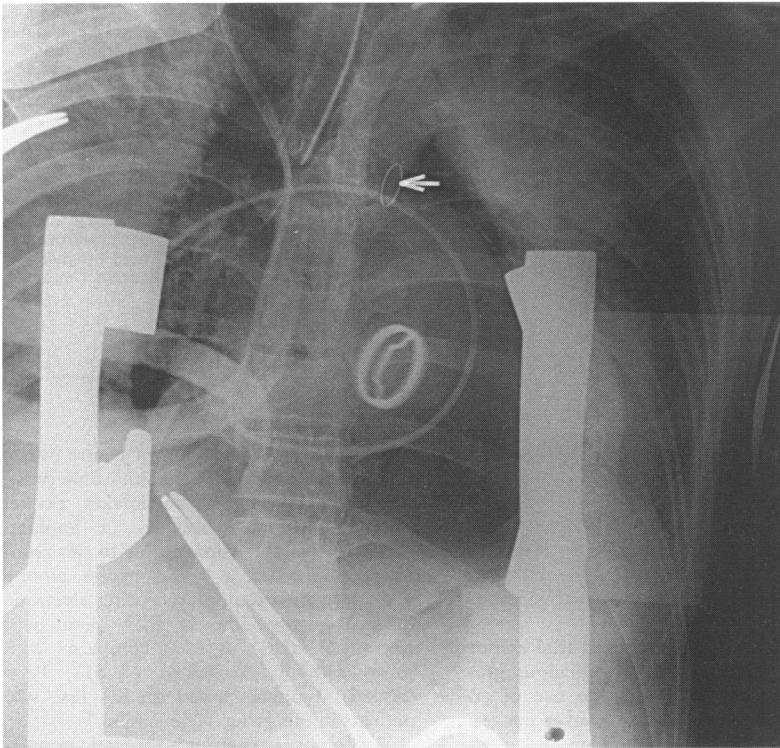
Figure 1 Intraoperative chest radiograph.

Figure 1 is the intra-operative chest radiograph from a 54 year old woman with a 60° Convexo-Concave Björk-Shiley mechanical mitral valve prosthesis who presented with cardiovascular collapse. She became alarmed when her prosthesis stopped clicking. Strut fracture was diagnosed and she was taken for immediate surgery. The sewing ring of the prosthesis is clearly shown positioned in the mitral annulus. The dislodged pyrolite disc (arrowed) lies in the aortic arch. Figure 2 shows the fractured strut (arrowed), which had held the disc in place, now lying in the iliac artery.

Most patients with Convexo-Concave valves in the United Kingdom have been notified of the risk of strut fracture and many carry Medic-Alert bracelets. If strut fracture is suspected, however, the most readily available and quickest investigation is an overpenetrated chest radiograph in both posteroanterior and lateral or oblique views. This may show absence of the strut or occluder disc or both from their usual position and possibly their location in another site. Immediate surgical intervention is the only treatment. It may result in complete recovery as it did with this patient who remains well one year after the event.

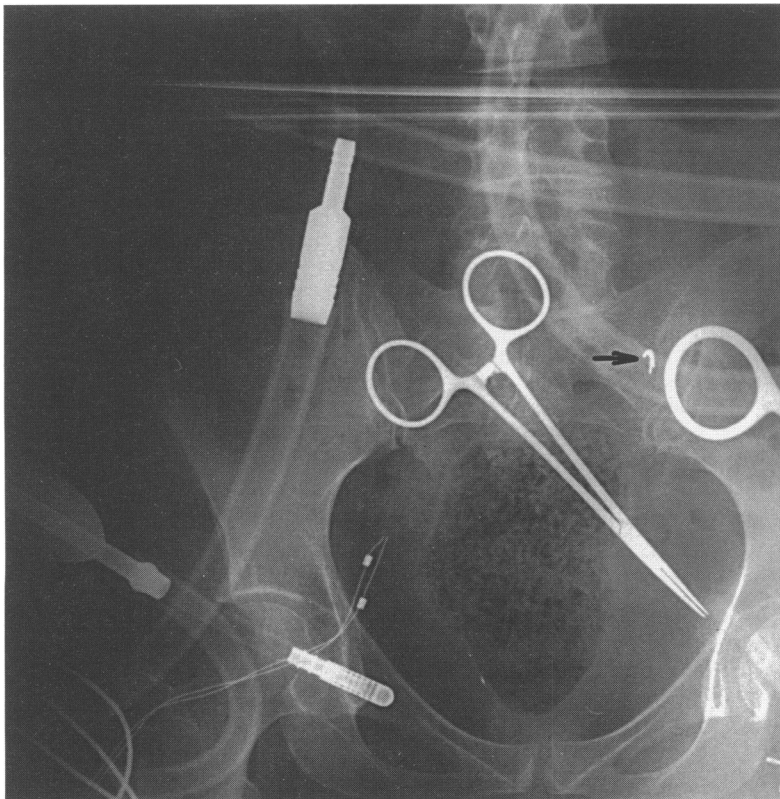
Figure 2 Intraoperative radiograph of pelvis.
